ON - LINE PARTIAL DISCHARGE

Re- Evaluating High Voltage Switchboard Insulation for the over 25 year olds!

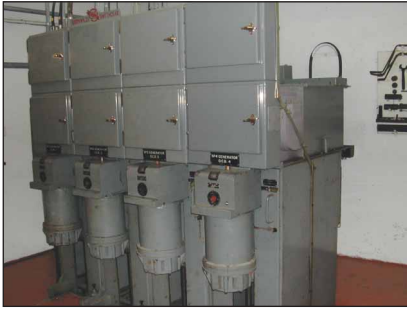
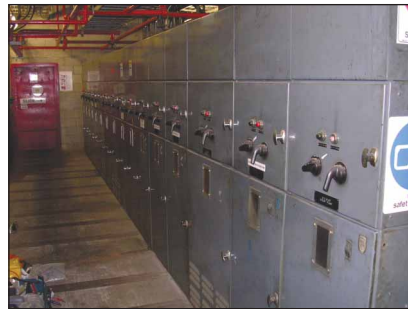
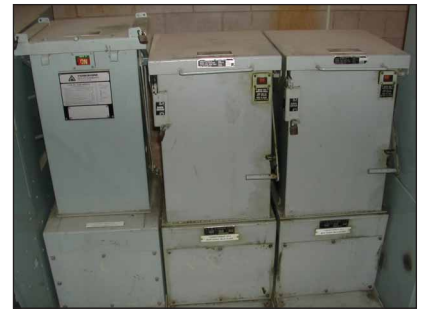
The Rogue's Gallery - typical 25 plus year old switchgear.

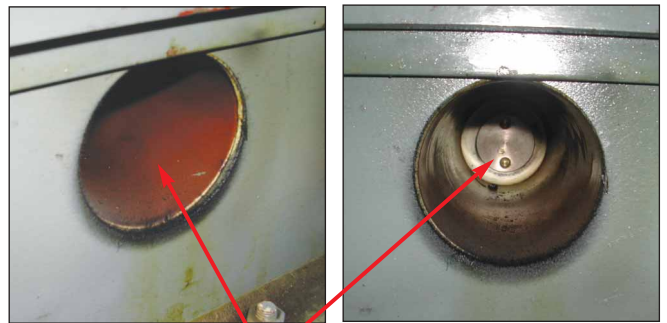
Partial Discharge was discovered in the voltage transformer. This VT was isolated from circuit and the following defects were found.

- Transformer oil tested poorly - (17kV flash over, highly acid, dark oil)
- Blue phase High Voltage fuse blown.
- Heavy Partial Discharge identified in the bushing spouts. (Refer Figure 1)
- Free roaming Iron / copper partials in bottom of tank and on ledges of VT.
- Protection scheme in-operative due to VT fuse blown (no alarm monitoring on VT supplies)

Figure 1: Heavy Partial Discharge on all three bushings.
