DETECTING PARTIAL DISCHARGE

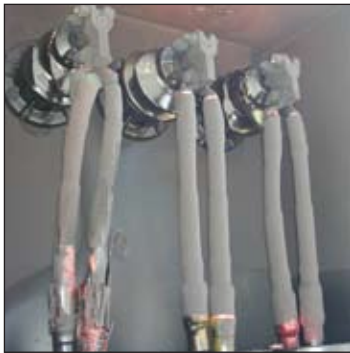
Termination failure in process (21-12-07)

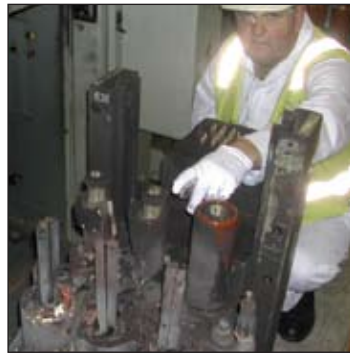
Failed AEI circuit breaker

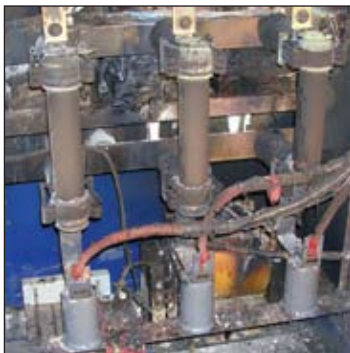
Generator Termination failure in process (21-1-08)

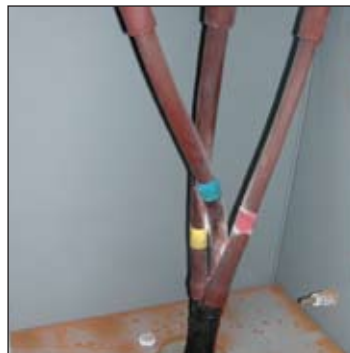
Termination failure in process (21-2-08)

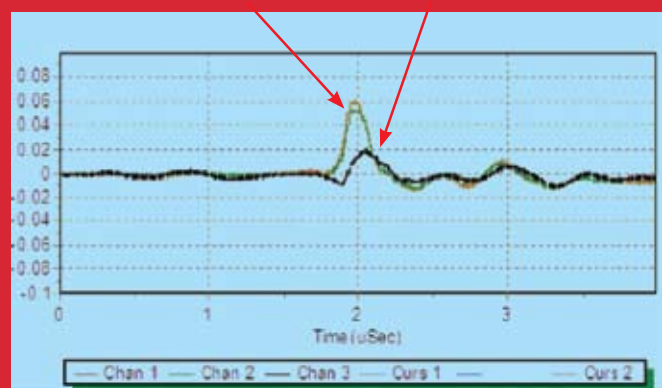
A recent On Line Partial Discharge Survey of a Central Business District network (New Zealand) showed an 11kV feeder with two locations of high partial discharge. By using PD detection and mapping of cables it was possible to locate the source of this discharge:

- One source was a pitch filled joint
- The second source was a pending oil filled switchgear failure.

We advised the client that the oil filled switchgear had a higher probability of failure compared to the paper lead pitch filled in-line joint. A planned outage occurred and the suspect switchgear was replaced.

Oil filled Switchgear

Pitch filled joint

A second PD survey was carried out which showed the levels of Partial Discharge had reduced. This allowed rescheduling of repairs to the joint until suitable access / loading had dropped (it was not possible to cut off the load to the cable).
