ON-LINE PARTIAL DISCHARGE CABLE MAPPING

CASE STUDY

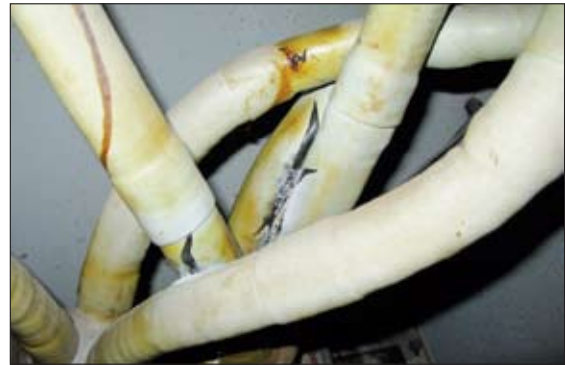
Figure 1 Failed termination located by Partial Discharge Engineers. Failing to locate this in a timely manner would have resulted in Figures 2 & 3 occurring.

A recent On Line Partial Discharge Survey of a coal mine operation in Australia showed an 11kV feeder with two locations of high partial discharge. By using PD detection and mapping of cables it was possible to locate the source of this discharge:

- One source was a pitch filled joint,
- The second source was a pending termination switchgear failure.

We advised the client that the termination in the switchgear had a higher probability of failure compared to the paper lead pitch filled in-line joint. A planned outage occurred and the suspect termination was replaced. A second PD survey carried out showed the levels of Partial Discharge had reduced. This allowed rescheduling of repairs to the joint until suitable access / loading had dropped (It was not possible to cut off the load to the cable).

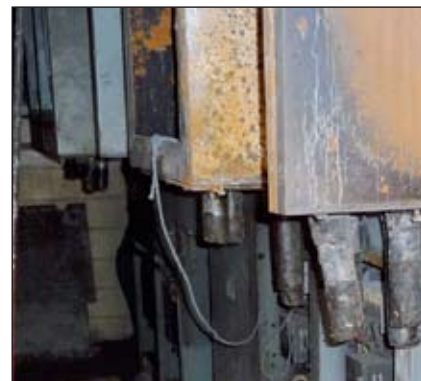
Figure 2 Termination failure, lead to entire HV switchboard failure (The rust is caused by foam used by the fire brigade)

- The damage caused by a termination failure can be catastrophic and in most cases will cause a forced outage on the entire HV switchboard. (See photos of damage HV switchboard caused by a termination failure below).

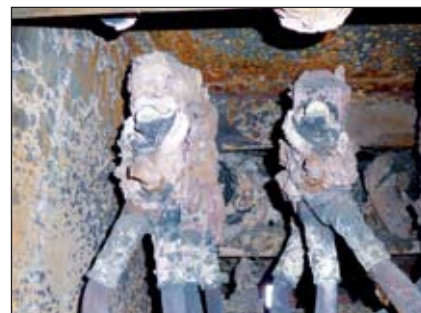
Figure 3 Remains of failed termination (Original cause of failure)
