RE-EVALUATING OIL FILLED CABLES USING ON-LINE PARTIAL DISCHARGE

In a recent Australian survey of 66 & 275kV oil filled cables, all testing was done on-line, under normal system operating conditions. Key areas such as end cable terminations, cross bonding pits and stop joints were surveyed. This On-Line Partial Discharge survey revealed the following defects:

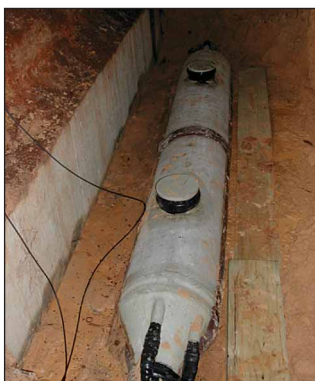
The oil stop joint was "mapped" out and an acoustic survey was conducted. It is not uncommon for discharges to occur in cable that have been in service for over 25 years with varying maintenance levels.

View of an exposed stop-joint prior to On-Line Partial Discharge survey.

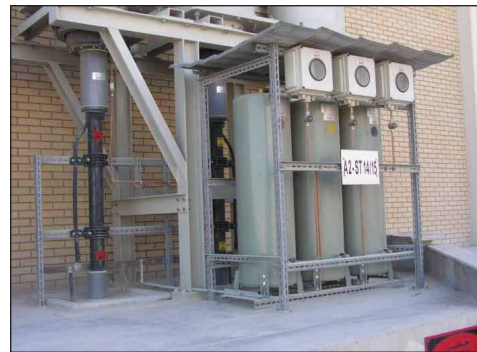
End terminations are also a source of Partial Discharge. When these areas are surveyed it not only checks the section of cable from the stop joint to the termination, but effectively all hardware associated the termination.

View of a typical SF₆ cable termination.
